# Manhole Inspection Summary

Manhole # S11E1\_005MH

Insp Date: **4/9/08 1:50 PM**

**Location** Address: **1521 S. Edgewood St**

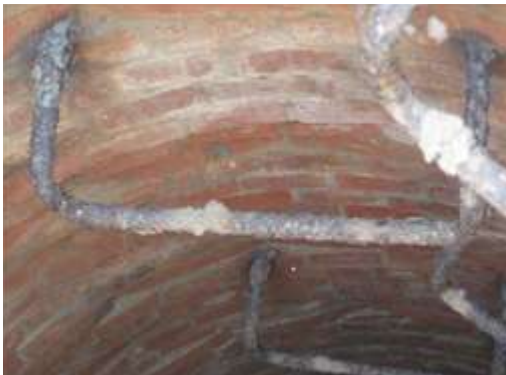
Defect 2

☒ **Corroded**

Corroded steps

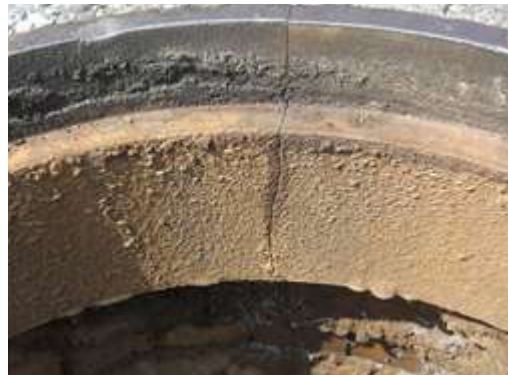
Defect 1

☒ **Cracked**

Cracked frame

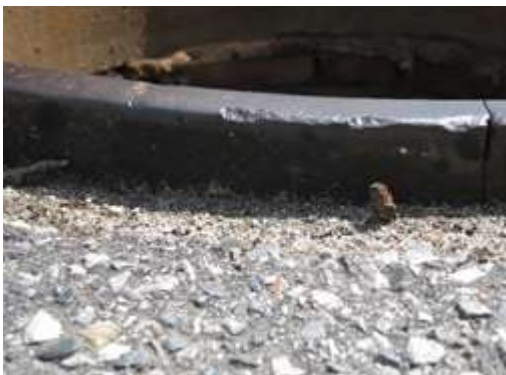
Defect 5

Frame cracked

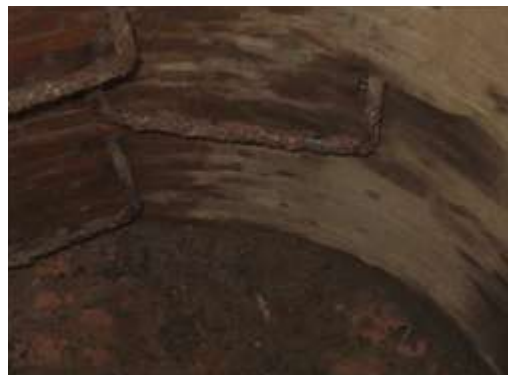
Defect 8

Signs of infiltration near steps

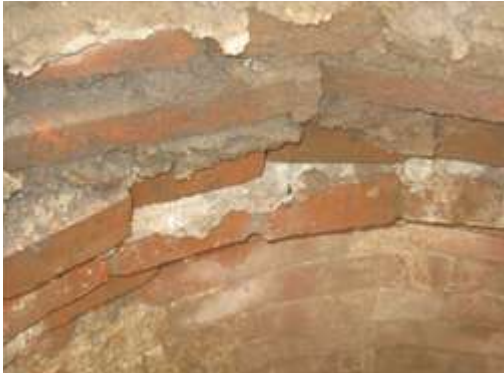
Defect 7

Signs of infiltration from top / Loose bricks and mortar

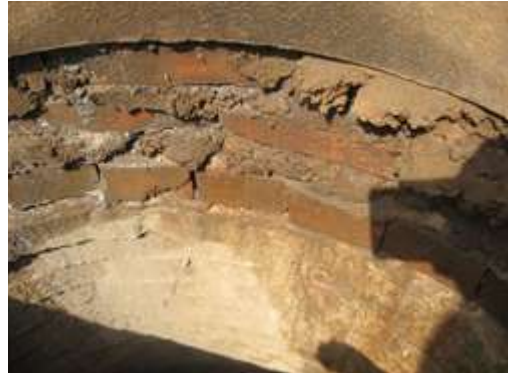
Defect 6

Loose bricks and mortar under frame/  
Infiltration at chimney

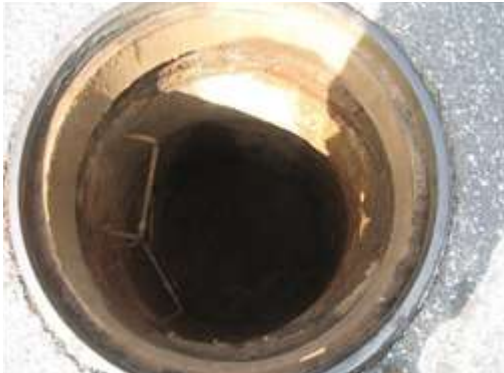
Defect 5

☒ **Leaks**

Frame cracked and leaks

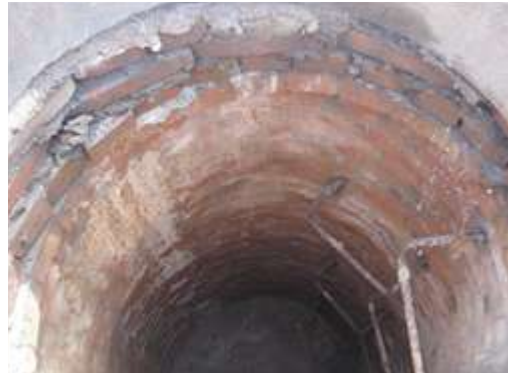
Defect 4

Loose Bricks at the chimney and  
Infiltration in chimney and corbel.

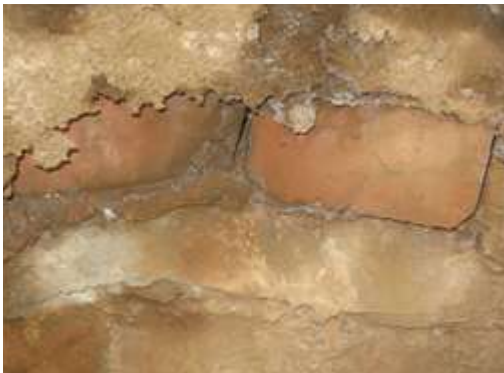
Defect 3

Evidence of infiltration at Chimney

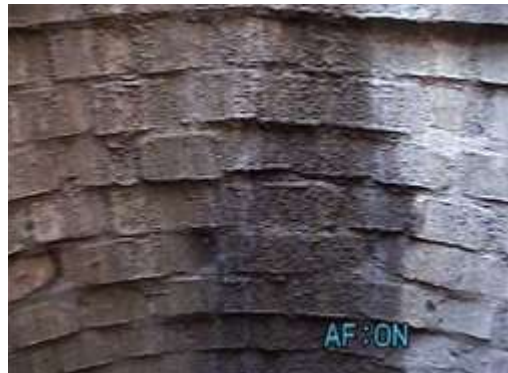
Defect 10

Infiltration along walls

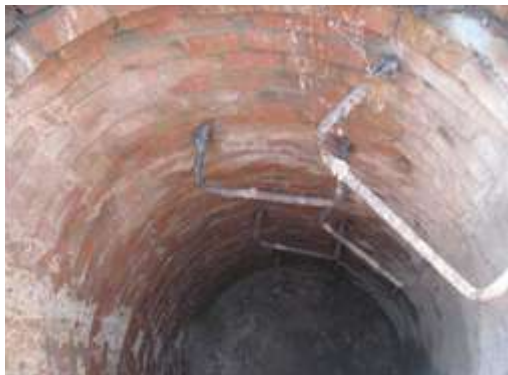
### Defect9

Signs of infiltraiton from top and along entire manhole wall

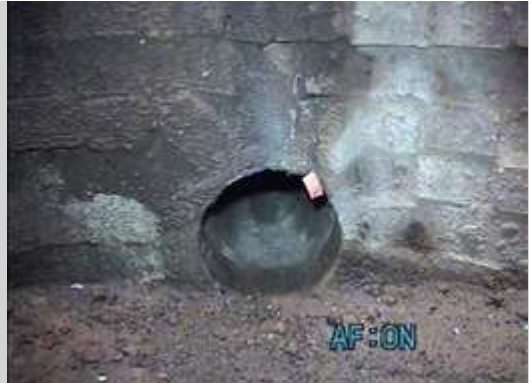
12 O'Clock Outflow

8 in. Circular Gravity Sewer  
Pipe Out @ 12 O'Clock

Infiltration: **None** Pipe Seal Cond: **Sound**
